Note: When upgrading from 1.xx or earlier software to any version of 2.0x software, you will need to verify that you have the necessary required disk space left on the drive to handle the additional 30MB of program and language files it contains.

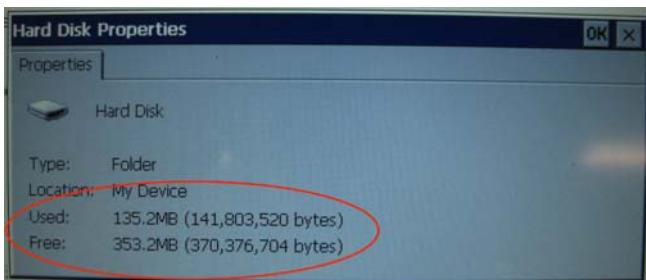
3. Observe the information contained in the POP-UP window. In the example shown below we have approximately 353MB left on the Hard Disk which is very good. If this number is less than 100MB then we recommend not installing the software on this dryer.
