Note: When upgrading from 1.xx or earlier software to any version of 2.0x software, you will need to verify that you have the necessary required disk space left on the drive to handle the additional 30MB of program and language files it contains.

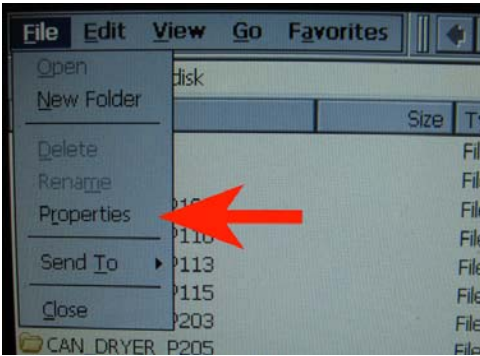
1. Power up the Vision controller. On the first screen select the 4th button labeled with either **Exit to Windows** or **Windows** located at the bottom of the page by tapping on the screen. Select YES on the POP-UP window to exit.
2. Once windows explorer loads you will be viewing the root folder of the disk drive. On this screen select the FILE pull down menu by tapping on FILE, and then select properties as shown below by tapping on PROPERTIES.

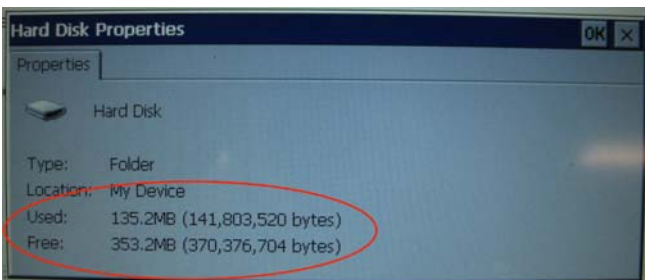
3. Observe the information contained in the POP-UP window. In the example shown below we have approximately 353MB left on the Hard Disk which is very good. If this number is less than 100MB then we recommend not installing the software on this dryer.
